**Flood Control Project Maintenance
Levee Inspections**
LMA District Cover Sheet
Spring 2017 Levee Inspection Results

Reclamation District No. 2096 Wetherbee Lake

Levee Inspection Report By Mile - Spring 2017

Waterway	Bank	Unit Miles	Inspection Start/End	Inspector
Unit No. 01 San Joaquin River	Right	0.16	04/11/2017 04/11/2017	Maksim Khashchuk

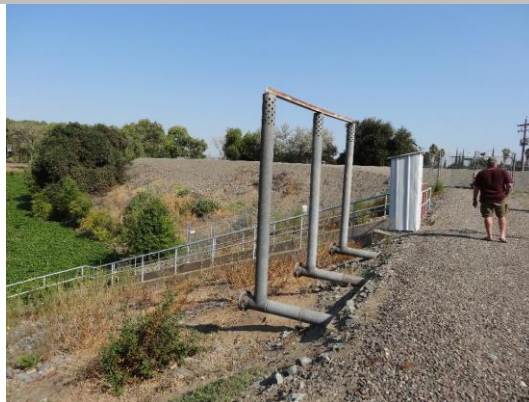
Photo 2 of 3 : UCIP_SP_2017_21505_36448.jpg

WS view: three air vents for three drainage pipes on levee shoulder.

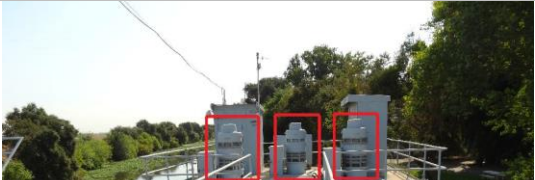
Photo 3 of 3 : UCIP_SP_2017_21505_36447.jpg

LS view: automatic pumping plant with three pumps. Steel walkway to pump platform.

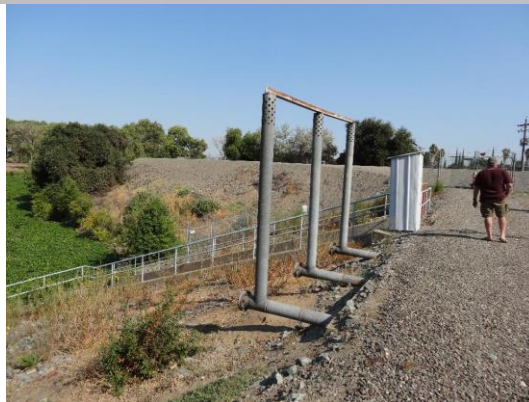
Photo 2 of 3 : UCIP_SP_2017_21508_36460.jpg

WS view: three air vents for three drainage pipes on levee shoulder.

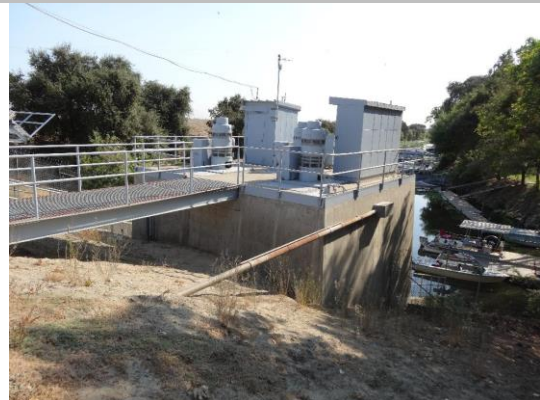
Photo 1 of 2 : UCIP_SP_2017_21506_36453.jpg

LM Start	0.03	Rating **	M	Issue No.	18
LM End	0.03	Issue Type +	En	Location *	N/A
Category	Supplemental			GPS Latitude/Longitude	
				Start	End
Item	DWR UCIP Field Study			37.773800 °	37.773800 °
				-121.298428 °	-121.298428 °
DWR ID					
Comment Code					
Inspector Comment					
FS_ID:21506					
DS_ID:24666					
EP_NO: N/A					
Repair Type: Non-Urgent					
Crossing Status: Found					
UCIP Comments: - more information needs to be find from LMA/DWR					
Inspector for this crossing. - needs to find whether this pipe passes					
through the levee.					
FIELD_STRUCT_DESC: A 4-inch steel pipe through the levee and to					
pump platform, 3 ft. below the crown. It is a element of pumping plant.					
Field study discovered utility crossing.					
FS Date: 9/10/2013

LS view: 4-inch steel pipe (right) through the levee and to pump platform.

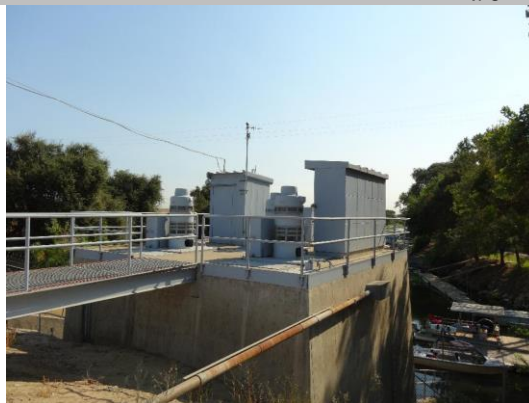
Photo 2 of 2 : UCIP_SP_2017_21506_36452.jpg

LM Start	0.03	Rating **	M	Issue No.	18 (cont)	
LM End	0.03	Issue Type +	En	Location *	N/A	
Category	Supplemental			GPS Latitude/Longitude		
				Start	End	
Item	DWR UCIP Field Study			37.773800 °	37.773800 °	
				-121.298428 °	-121.298428 °	
DWR ID						
Comment Code						
Inspector Comment						
FS_ID:21506						
DS_ID:24666						
EP_NO: N/A						
Repair Type: Non-Urgent						
Crossing Status: Found						
UCIP Comments: - more information needs to be find from LMA/DWR						
Inspector for this crossing. - needs to find whether this pipe passes						
through the levee.						
FIELD_STRUCT_DESC: A 4-inch steel pipe through the levee and to						
pump platform, 3 ft. below the crown. It is a element of pumping plant.						
Field study discovered utility crossing.						
FS Date: 9/10/2013

LS view: closer view of 4-inch steel pipe (left) through the levee and to pump platform.

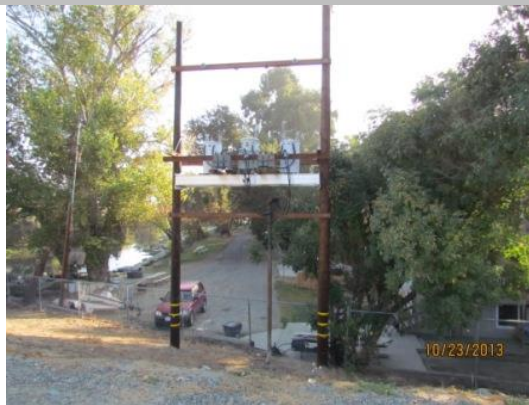
Photo 1 of 1 : SP_2017_RD2096_117_8_20170407_00003.jpg

LM Start	0.05	Rating **	A/W	Issue No.	8
LM End	0.05	Issue Type +	En	Location *	LS
Category	Earthen Levee			GPS Latitude/Longitude	
				Start	End
Item	Encroachments			37.773479 °	37.773479 °
				-121.298486 °	-121.298486 °
DWR ID	DWR_RD2096_01_f_2013_8				
Comment Code					
PO : Pole					
Inspector Comment					
Two telephone poles at landside levee toe.

View of the telephone poles at the landside levee toe.

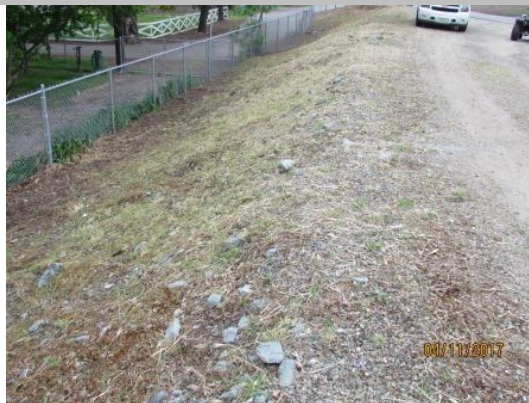
Photo 1 of 1 : SP_2017_RD2096_117_14_20170417_00020.jpg

LM Start	0.09	Rating **	A	Issue No.	14
LM End	0.09	Issue Type +	Ma	Location *	LS
Category	Earthen Levee			GPS Latitude/Longitude	
				Start	End
Item	Vegetation			37.772896 °	37.772896 °
				-121.298474 °	-121.298474 °
DWR ID	DWR_RD2096_01_s_2017_14				
Comment Code					
V1 : Control annual grass and weeds on the levee slopes and easements.					
Inspector Comment					
Acceptable vegetation control on the levee slope.

View of the acceptable vegetation on the levee slope.

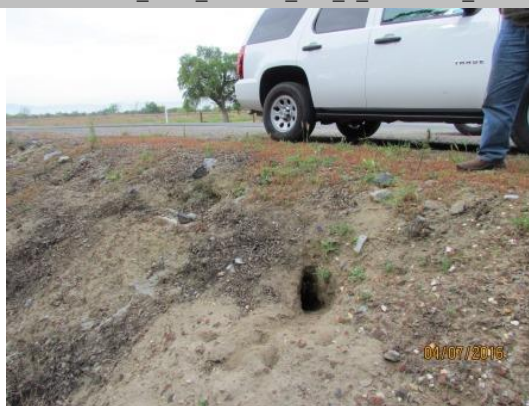
Photo 1 of 1 : SP_2017_RD2096_117_6_20170407_00002.jpg

LM Start	0.09	Rating **	A/W	Issue No.	6
LM End	0.09	Issue Type +	Ma	Location *	LS
Category	Earthen Levee			GPS Latitude/Longitude	
				Start	End
Item	Animal Control			37.772891 °	37.772891 °
				-121.298454 °	-121.298454 °
DWR ID	DWR_RD2096_01_s_2016_6				
Comment Code					
A3 : No rodents visible, but rodent burrows visible; need to backfill and compact or grout burrows.					
Inspector Comment					
LMA has effective rodent control program. Monitor this location for possible future activity.

View of the rodent hole on the landside levee slope.

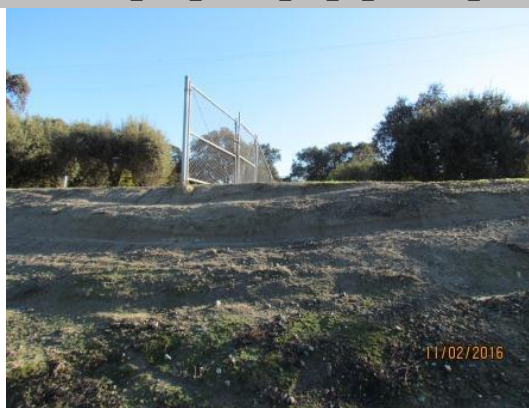
Photo 1 of 3 : SP_2017_RD2096_117_11_20170407_00005.jpg

View of the waterside slope damaged by vehicle.

LM Start	0.12	Rating **	M	Issue No.	11
LM End	0.12	Issue Type +	Ma	Location *	WS
Category	Earthen Levee			GPS Latitude/Longitude	
				Start	End
Item	Slope Stability			37.772434 °	37.772434 °
				-121.298433 °	-121.298433 °
DWR ID	DWR_RD2096_01_s_2015_11				
Comment Code					
S3 : Repair the levee slope damaged by vehicle traffic and prevent access where possible.					
Inspector Comment					
Regrade and re-compact damaged waterside levee slope.

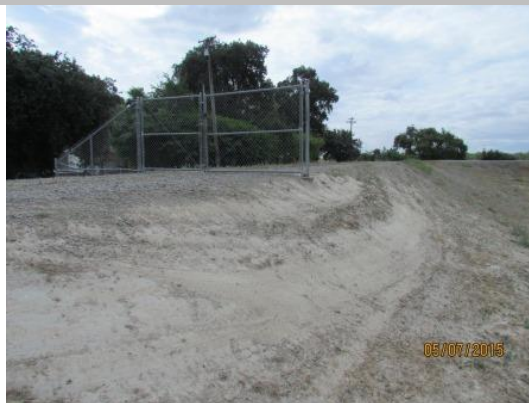
Photo 2 of 3 : SP_2017_RD2096_117_11_20170407_00006.jpg

View of the vehicle tracks eroding the waterside levee slope.
